**Flood Control Project Maintenance
Levee Inspections**

Maintenance Issue Types Only, Levee Inspection Report By Mile - Fall 2016

Sutter Maintenance Yard East-West Interceptor

Waterway	Bank	Unit Miles	Inspection Start/End	Inspector
Unit No. 01 West Levee	Right	1.75	11/02/2016 11/02/2016	Tariq Chechi

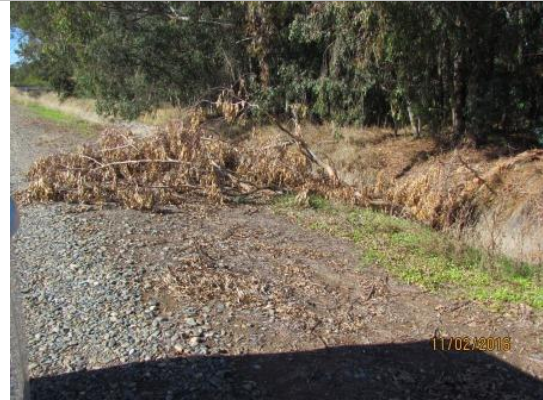
Photo 1 of 1 : FA_2016_ST0020_213_14_20161107_00018.jpg

LM Start	0.43	Rating **	M	Issue No.	14
LM End	0.43	Issue Type +	Ma	Location *	WS
Category	Earthen Levee			GPS Latitude/Longitude	
				Start	End
Item	Encroachments			39.171422°	39.171422°
				-121.751978°	-121.751978°
DWR ID	DWR_ST0020_01_f_2016_14				
Comment Code					
TR : Tree or limb					
Inspector Comment					
Remove the tree limb from the waterside.

View of a fallen limb.

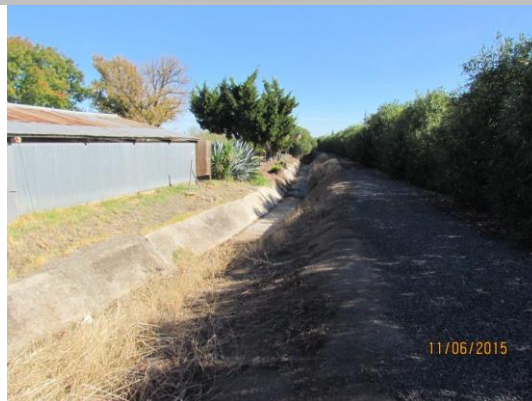
Photo 1 of 2 : FA_2016_ST0020_213_4_20160823_00005.jpg

LM Start	0.62	Rating **	U	Issue No.	4
LM End	0.65	Issue Type +	Ma	Location *	WS
Category	Earthen Levee			GPS Latitude/Longitude	
				Start	End
Item	Erosion / Bank Caving			39.171292 °	39.171232 °
				-121.748868 °	-121.748175 °
DWR ID	DWR_NA0020_01_s_2012_4				
Comment Code					
E2 : Schedule repair of erosion site prior to the next inspection.					
Inspector Comment					
Repair the erosion along the concrete ditch.

View the erosion along the concrete ditch.

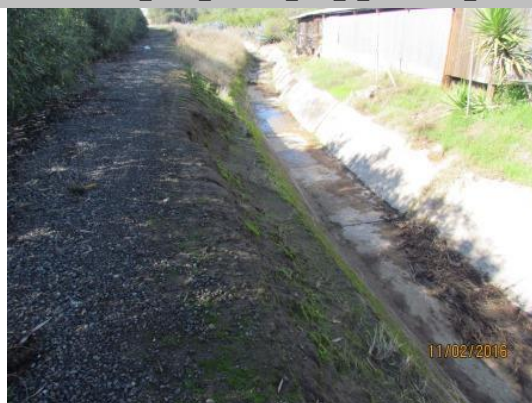
Photo 2 of 2 : FA_2016_ST0020_213_4_20161107_00020.jpg

Another view the erosion along the concrete ditch.

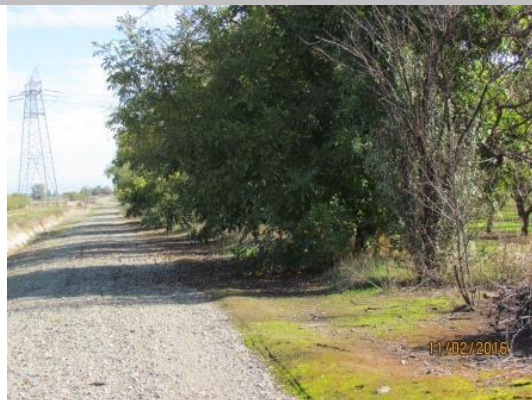
Photo 1 of 1 : FA_2016_ST0020_213_18_20161107_00024.jpg

LM Start	1.11	Rating **	M	Issue No.	18
LM End	1.28	Issue Type +	Ma	Location *	LS
Category	Earthen Levee			GPS Latitude/Longitude	
				Start	End
Item	Trim / Thin Trees			39.171283°	39.171243°
				-121.739315°	-121.736312°
DWR ID	DWR_ST0020_01_f_2016_18				
Comment Code					
T1 : Trim trees to at least five feet above ground level.					
Inspector Comment

View of the trees blocking visibility.

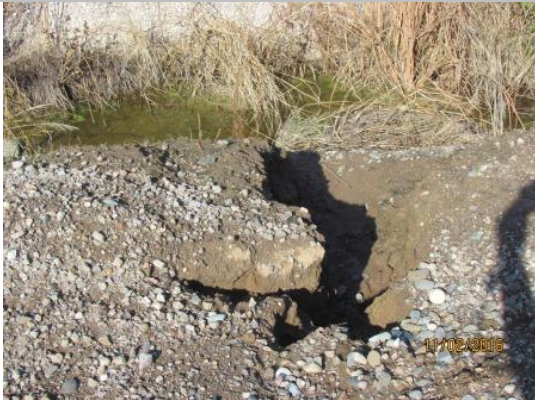
Photo 1 of 1 : FA_2016_ST0020_213_22_20161107_00026.jpg

View of the erosion along the bank.

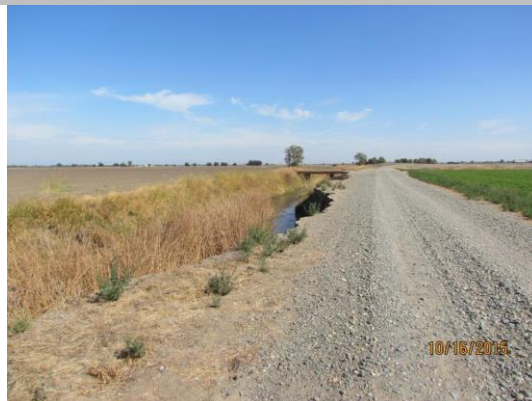
Photo 2 of 2 : FA_2016_ST0020_213_6_20160823_00008.jpg

LM Start	1.65	Rating **	U	Issue No.	6 (cont)	
LM End	1.65	Issue Type +	Ma	Location *	WS	
Category	Rivers, Channels & Designated Floodways			GPS Latitude/Longitude		
				Start		End
Item	Erosion / Bank Caving			39.171132°		39.171132°
				-121.729312°		-121.729312°
DWR ID	DWR_NA0020_01_s_2012_6					
Comment Code						
Inspector Comment						
Sutter Yard needs to repair the erosion before winter.

Repair the erosion along the waterside slope.

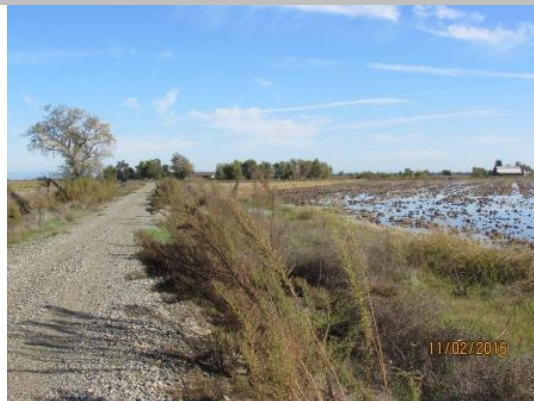
Photo 1 of 1 : FA_2016_ST0020_214_11_20161107_00045.jpg

LM Start	0.00	Rating **	M	Issue No.	11
LM End	0.26	Issue Type +	Ma	Location *	LS
Category	Earthen Levee			GPS Latitude/Longitude	
				Start	End
Item	Vegetation			39.171116°	39.171101°
				-121.726501°	-121.721857°
DWR ID	DWR_NA0020_02_s_2012_11				
Comment Code					
V1 : Control annual grass and weeds on the levee slopes and easements.					
Inspector Comment

View of the annual grass along the landside slope.

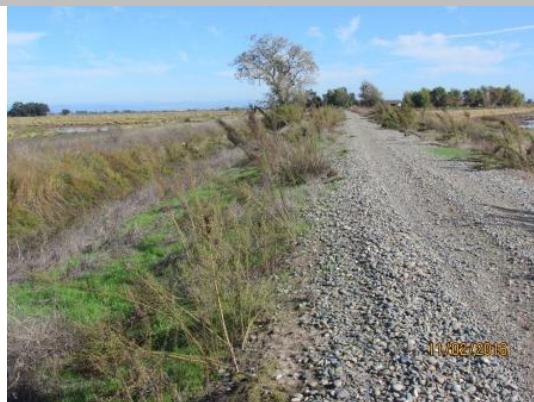
Photo 1 of 1 : FA_2016_ST0020_214_24_20161107_00046.jpg

LM Start	0.03	Rating **	M	Issue No.	24
LM End	0.25	Issue Type +	Ma	Location *	WS
Category	Earthen Levee			GPS Latitude/Longitude	
				Start	End
Item	Vegetation			39.171152°	39.171160°
				-121.725937°	-121.721673°
DWR ID	DWR_ST0020_02_f_2016_24				
Comment Code					
V1 : Control annual grass and weeds on the levee slopes and easements.					
Inspector Comment

View of the annual grass along the waterside slope.

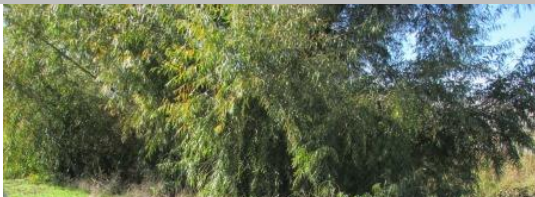
Photo 1 of 1 : FA_2016_ST0020_214_31_20161107_00047.jpg

View of the overgrown trees blocking visibility and access.

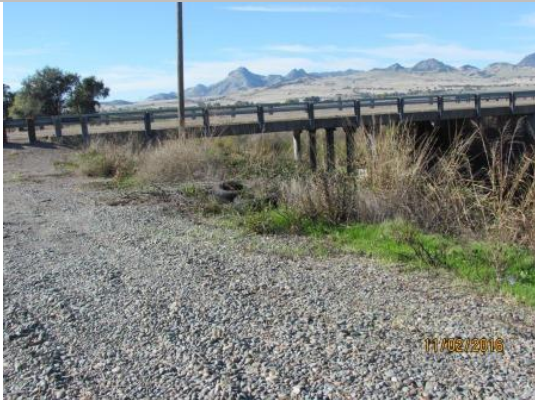
Photo 1 of 1 : FA_2016_ST0020_214_28_20161107_00049.jpg

View of the tires along the waterside berm.

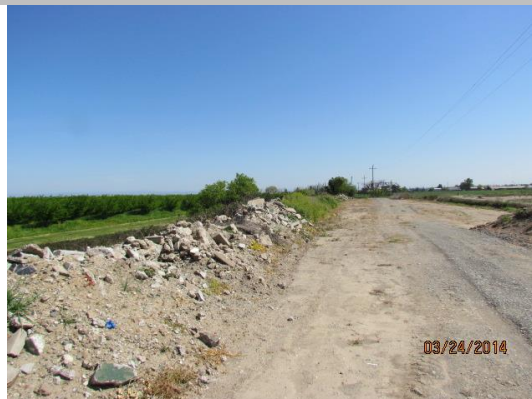
Photo 1 of 2 : FA_2016_ST0020_214_3_20160823_00003.jpg

LM Start	1.43	Rating **	M	Issue No.	3
LM End	1.52	Issue Type +	Ma	Location *	LS
Category	Earthen Levee			GPS Latitude/Longitude	
				Start	End
Item	Encroachments			39.170782 °	39.170865 °
				-121.700167 °	-121.698165 °
DWR ID	DWR_NA0020_02_s_2012_3				
Comment Code					
DE : Debris					
Inspector Comment					
Remove the broken concrete.

View of the piles of broken concrete.

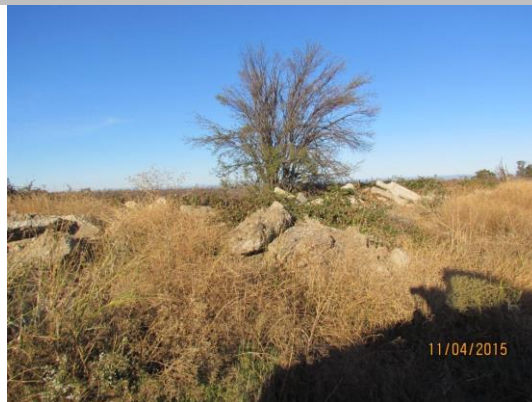
Photo 2 of 2 : FA_2016_ST0020_214_3_20160823_00004.jpg

View of the pile of broken concrete.

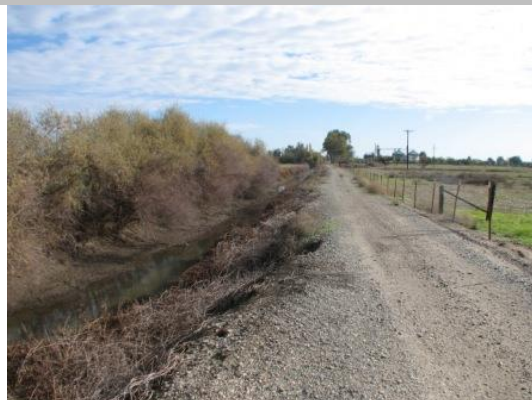
Photo 1 of 2 : FA_2016_ST0020_214_4_20160823_00005.jpg

LM Start	1.54	Rating **	M	Issue No.	4
LM End	2.01	Issue Type +	Ma	Location *	WS
Category	Earthen Levee			GPS Latitude/Longitude	
				Start	End
Item	Erosion / Bank Caving			39.170800 °	39.170732 °
				-121.698105 °	-121.689082 °
DWR ID	DWR_NA0020_02_s_2012_4				
Comment Code					
E1 : Note and monitor erosion site.					
Inspector Comment					
Monitor the erosion along the waterside slope.

View of the erosion along the waterside slope.

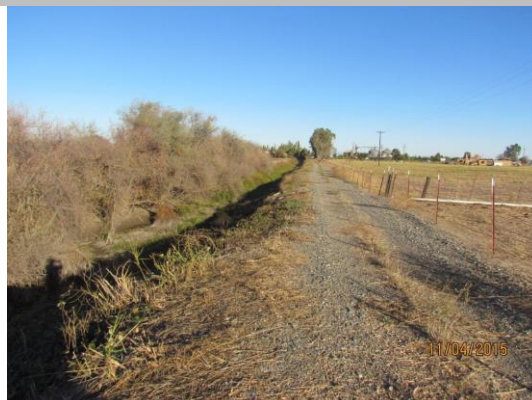
Photo 2 of 2 : FA_2016_ST0020_214_4_20160823_00006.jpg

View of the erosion along the waterside slope.

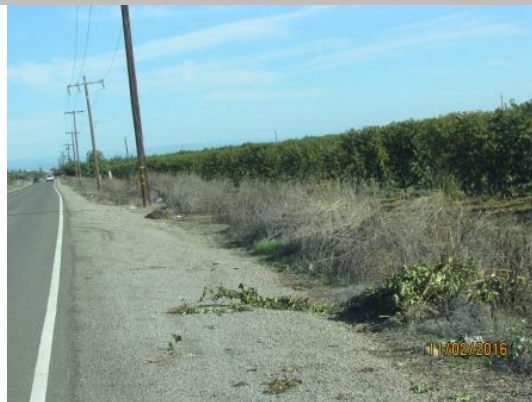
Photo 1 of 1 : FA_2016_ST0020_214_6_20161107_00051.jpg

LM Start	2.11	Rating **	M	Issue No.	6
LM End	2.36	Issue Type +	Ma	Location *	LS
Category	Earthen Levee			GPS Latitude/Longitude	
				Start	End
Item	Vegetation			39.170515 °	39.170518 °
				-121.687342 °	-121.682658 °
DWR ID	DWR_ST0020_02_f_2016_6				
Comment Code					
V1 : Control annual grass and weeds on the levee slopes and easements.					
Inspector Comment

View of the annual grass along the landside slope blocking visibility.

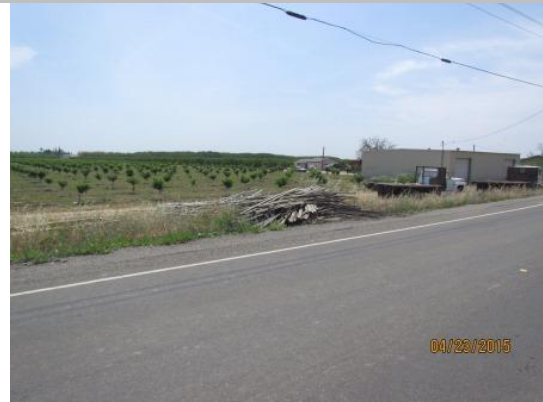
Photo 1 of 1 : FA_2016_ST0020_214_10_20160823_00010.jpg

LM Start	2.71	Rating **	M	Issue No.	10
LM End	2.71	Issue Type +	Ma	Location *	LS
Category	Earthen Levee			GPS Latitude/Longitude	
				Start	End
Item	Encroachments			39.170548 °	39.170548 °
				-121.675970 °	-121.675970 °
DWR ID	DWR_NA0020_02_s_2012_10				
Comment Code					
MA : Material					
Inspector Comment					
Remove the lumber, garbage and equipment from the landside toe.

View of the material, garbage, and equipment along the landside toe
